Bulletin # BU-932

SERVICE BULLETIN

Ride Name: StarTrooper

AIR BRAKE LINES

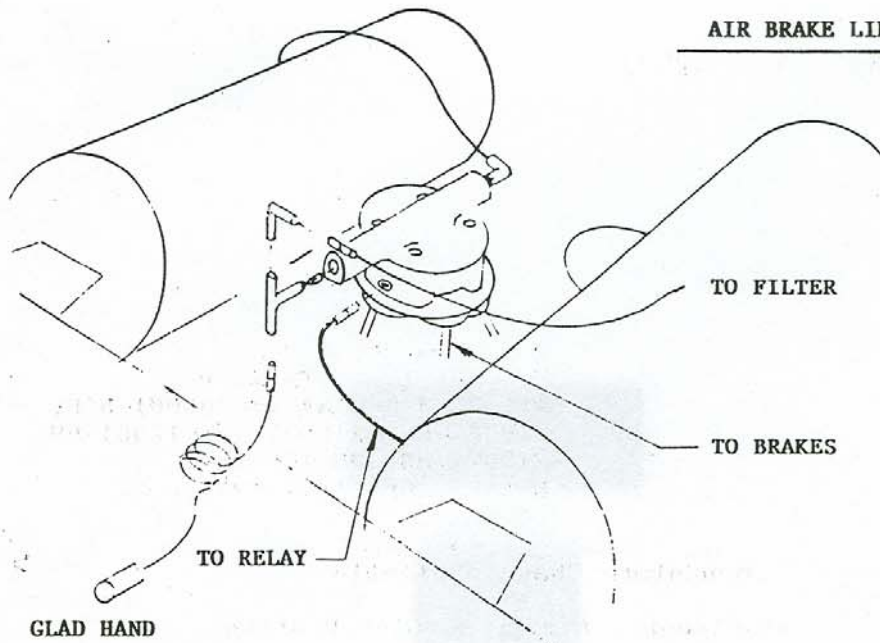
**EXHIBIT A CORRECT
VIEWED FROM REAR BUMPER**

Summary of Issue: Please review the attached drawing. If the spring break valve on your StarTrooper is plumbed like Exhibit B change the plumbing to match Exhibit A.

1. Remove airline to relay valve from "T" connection.
2. Connect the airline to relay valve into plugged port.
3. Remove the airline to the filter from "T" connection.
4. Replace "T" connection with a 90-degree elbow.
5. Connect the airline to the filter to the 90-degree elbow.

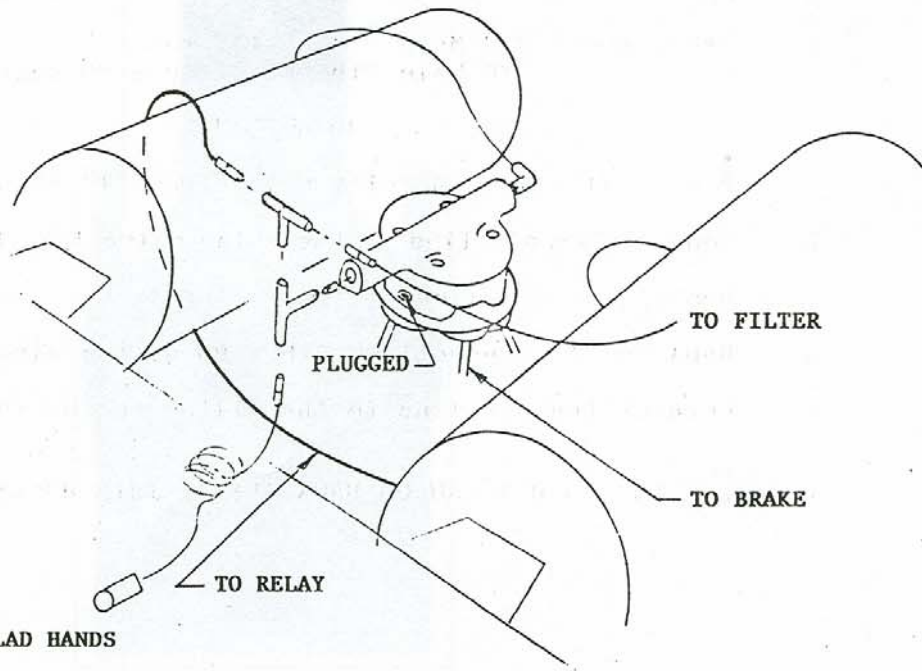
EXHIBIT B NOT CORRECT

Reason for release: It is possible that the trailer brakes on some StarTrooper's were incorrectly plumbed. The incorrect plumbing does not effect the operation of the trailer brakes. However, when the StarTrooper is disconnected from the tractor air will not be trapped in the holding tank. Several minutes will be required to build up air in the tank before departing. Changing plumbing to the configuration of Exhibit A will correct this problem.
