Dartron

Bulletin # SB-5K-001

SERVICE BULLETIN

Ride Manufacturer: Dartron Industries, Inc.	Affected Production Dates: All Cliff Hanger Rides
Ride Name: Cliff Hanger	Affected Serial #'s: All
Model #'s: All

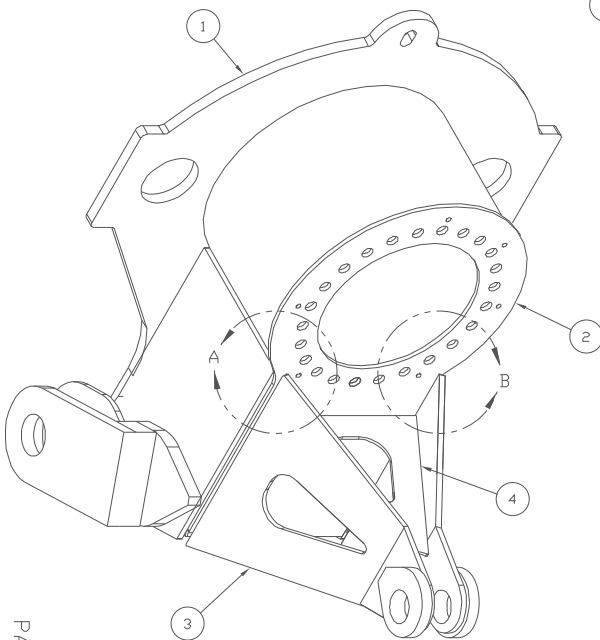
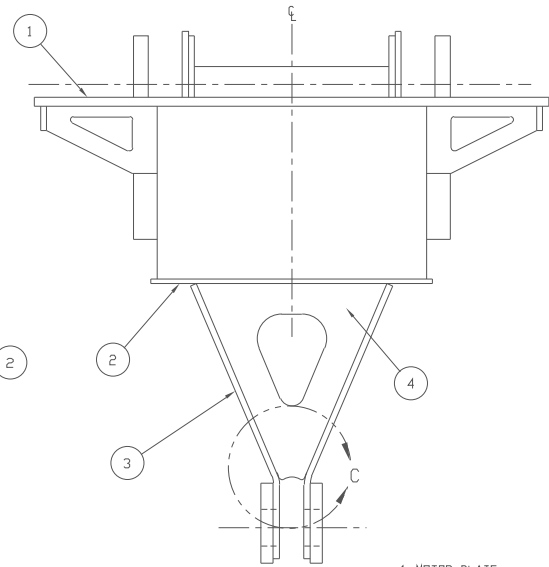
PAGE 3

Step 3: Three areas must be visually inspected. Those areas are shown on Page 3 as Detail A, B and C.

Step 5: Visually inspect the three areas for cracks or broken paint.

- 1. MOTOR PLATE
- 2. BEARING BASE
- 3. BOTTOM PLATE
- 4. LOWER PLATES
