Bulletin # PI-931

PRODUCT IMPROVEMENT

Ride Name: StarTrooper

Abstract of Issue: StarTrooper bushing change

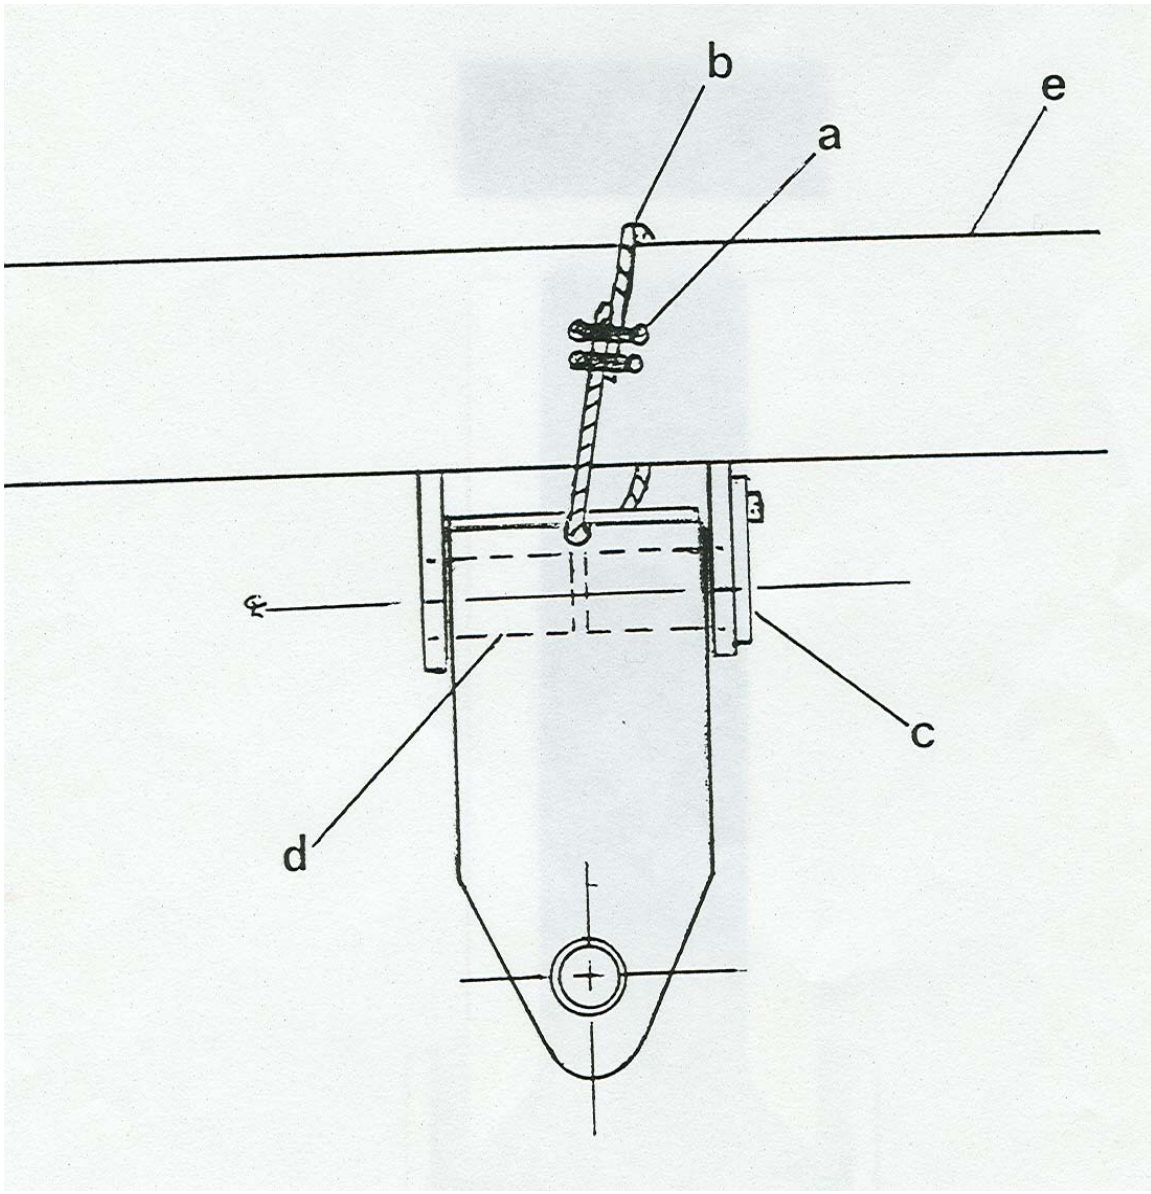
Reason for release: The upper hanger bushings are manufactured from a material called Nylatron. Under certain circumstances moisture can cause the Nylatron to expand and create tightness between the upper hanger block pin and the Nylatron bushing. Generally, the rotating action of the pin will create free movement between the pin and bushing. However, if tightness persists, we recommend that the following procedure be used to replace the Nylatron bushing with a pre lubricated bronze bushing. The bronze bushing has graphite impregnated in oval grooves and does not require periodic lubrication by ride operator. No zerk fitting is present because of this.

Directions for upper hanger block bushing change from Nylatron to bronze/graphite bushing.

Step One: Remove Hanger Block

1. Loosen thimble clamps (a) on attached drawing on safety cables (b) and remove cable.
2. Unbolt hanger block pin and remove pin (c) by carefully tapping end of pin with an aluminum bar and mallet so as not to damage the pin.

Step Two: Press Nylatron bushings (d) out of upper portion of hanger block with bushing driver. Replace with bronze bushings. Dartron is supplying bushing removal driver and bushings.

Step Three: Install Hanger Block to Bow (e)

1. Grease pin (c) before pinning hanger block in place.
2. Reattach safety cable (b)
