Bulletin # 4039

SERVICE BULLETIN

Ride Name: StarTrooper

Abstract of Issue: StarTrooper Front Car Storage Rack.

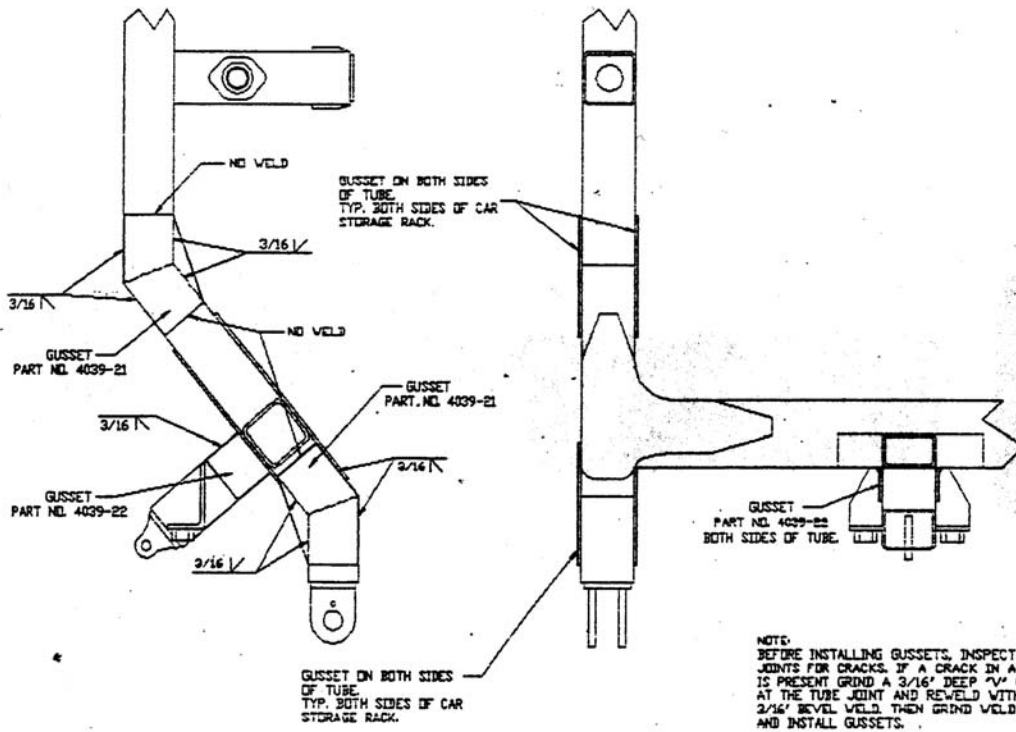
Bulletin No. 4039
Product: StarTrooper

As a result of moving the StarTrooper long distances over rough roads, cracks could develop in certain welded joints in the front car storage rack. If the cracks are not addressed, the joint could separate and cause the cars carried by this rack to drop during transit.

1. Immediately inspect area shown on the attached drawings for cracking.
2. If cracks are detected, immediately install gussets as shown in attached drawing.
3. If cracks are not detected, gussets still must be added no later than March 1, 1996.

<u>Description</u>	<u>Part #</u>	<u>Quantity</u>
Gusset	4039-21	8
Formed Gusset	4039-22	2

Welding Specifications: weld with 70,000-psi filler.
